INTERSECTION IMPROVEMENTS REPORT FOR LITTLE ROAD AT MASSACHUSETTS AVENUE AND DECUBELLIS ROAD

(PROJECT NO. C-10032.00) | AUGUST 2011

Johnson Engineering, Inc.
20525 Amberfield Drive
Land O'Lakes, Florida 34638
(813) 909-8099 | E B 642

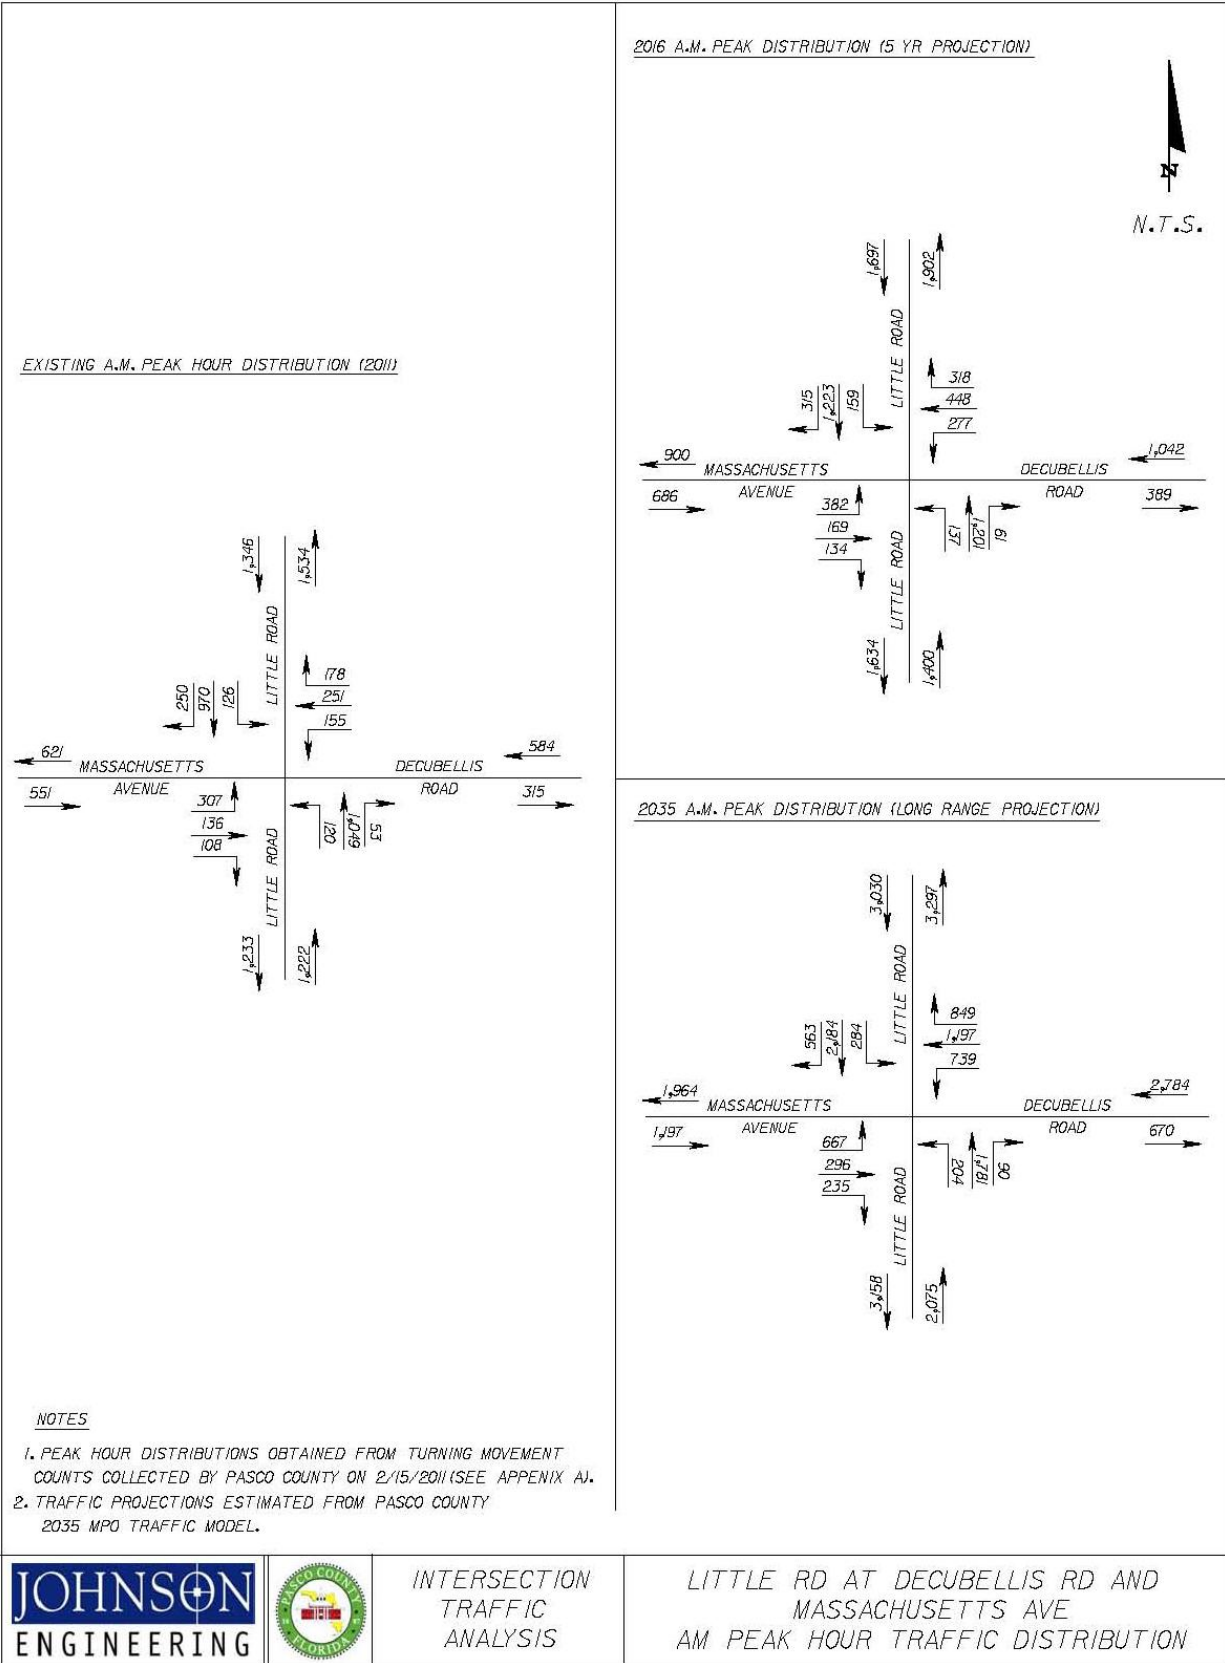
Figure 5-1: A.M. Peak Hour Traffic Distribution

Turning movement counts collected on February 15, 2011 from 8:00 a.m. to 9:00 a.m. and from 2:00 p.m. to 3:00 p.m. were provided by Pasco County to serve as the base traffic conditions for the intersection of Little Road at Massachusetts Avenue and Decubellis Road traffic analysis. Directional 24-hour volume counts were also provided for each leg of the intersection (see Appendix A).

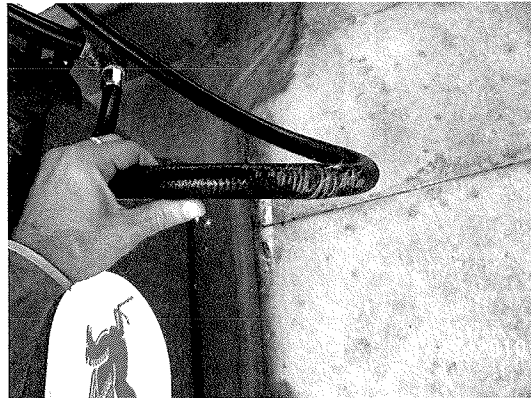
Worn #11 Hose.

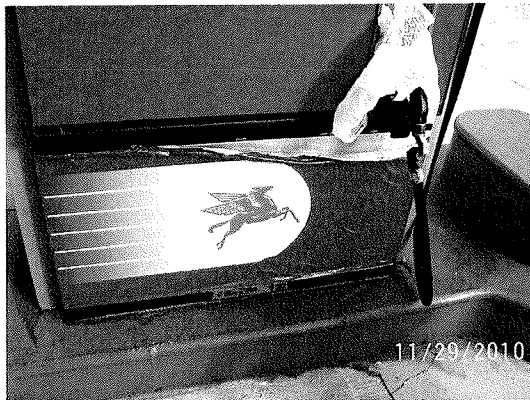
#3/4 dispenser. (Note damaged decal from product leak.)

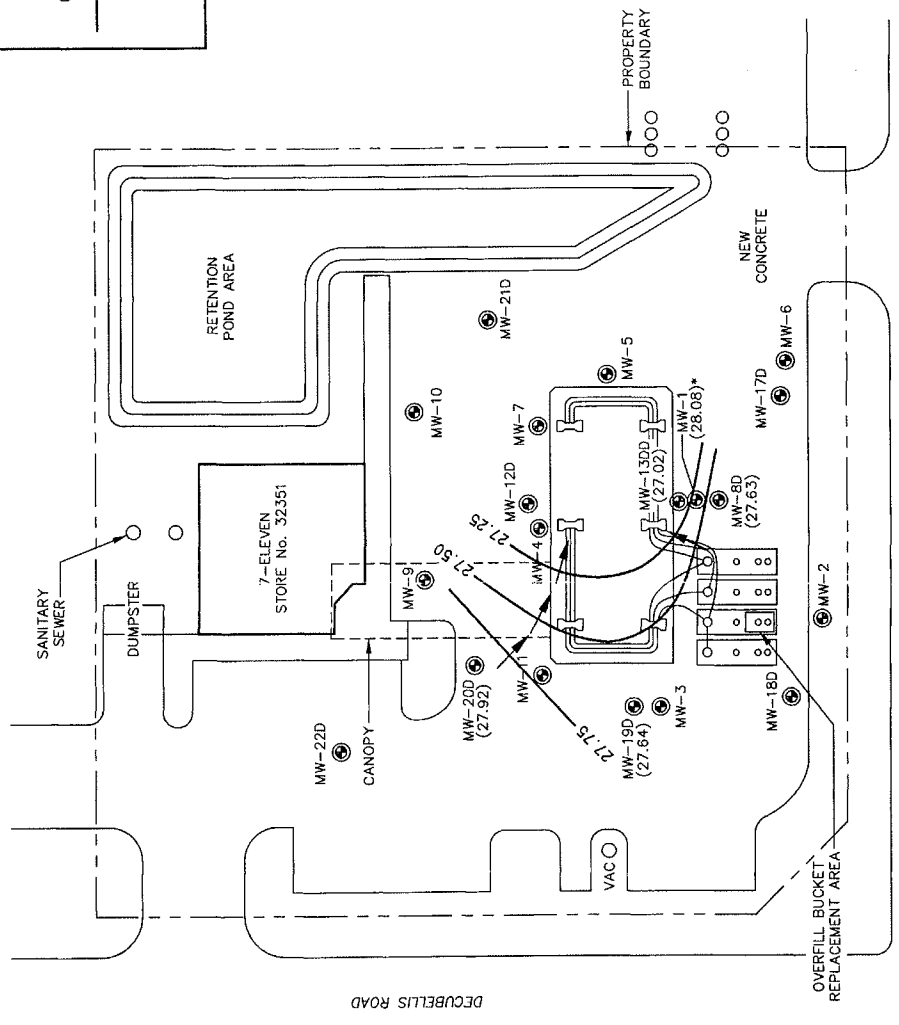
FIGURE 3
GROUNDWATER ELEVATION CONTOUR MAP IN THE FLORIDAN AQUIFER
 DECEMBER 15, 2010
 7-ELEVEN STORE No. 32351
 6926 LITTLE ROAD
 NEW PORT RICHEY, FLORIDA

- ⊙ MONITORING WELL LOCATION
- (27.92) GROUNDWATER ELEVATION (FEET)
- 27.50— GROUNDWATER ELEVATION CONTOUR
- GROUNDWATER FLOW DIRECTION
- * DATA NOT USED TO DETERMINE CONTOURS

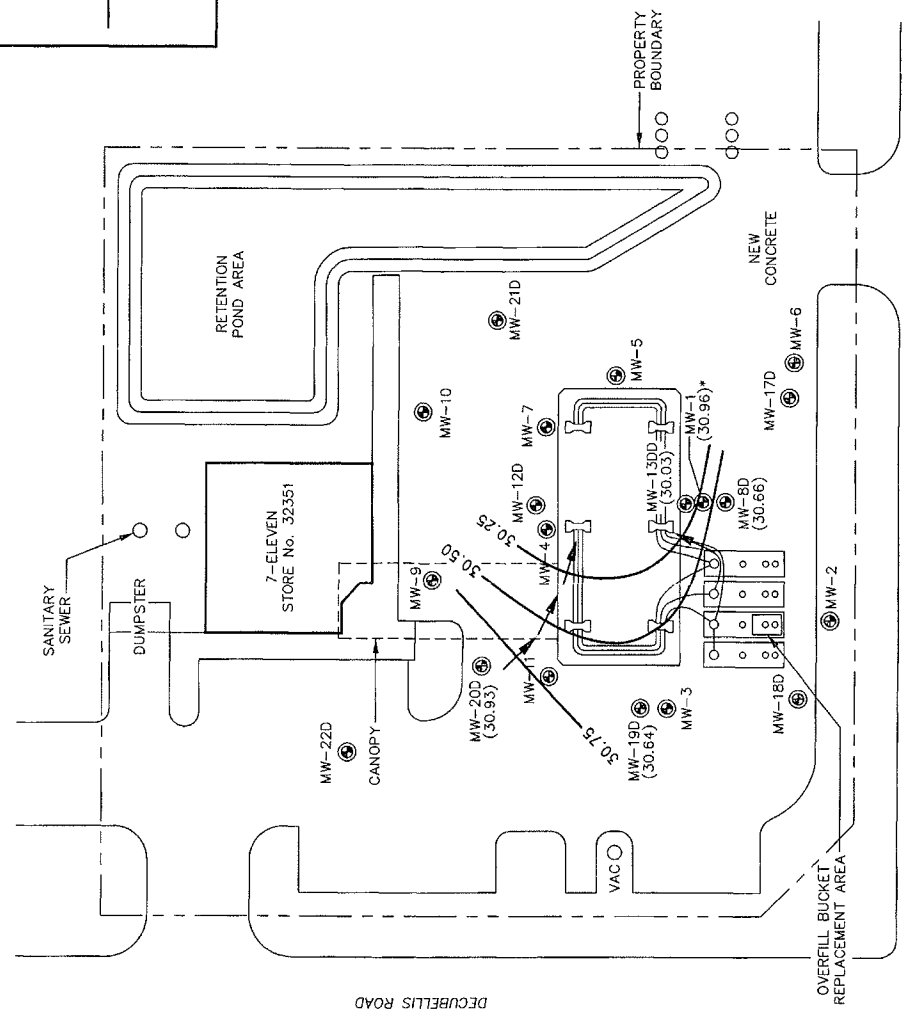
FIGURE 3
GROUNDWATER ELEVATION CONTOUR MAP IN THE FLORIDAN AQUIFER
 SEPTEMBER 16, 2010
 7-ELEVEN STORE No. 32351
 6926 LITTLE ROAD
 NEW PORT RICHEY, FLORIDA

MONITORING WELL LOCATION
	GROUNDWATER ELEVATION (FEET)
	GROUNDWATER ELEVATION CONTOUR
	GROUNDWATER FLOW DIRECTION
	DATA NOT USED TO DETERMINE CONTOURS

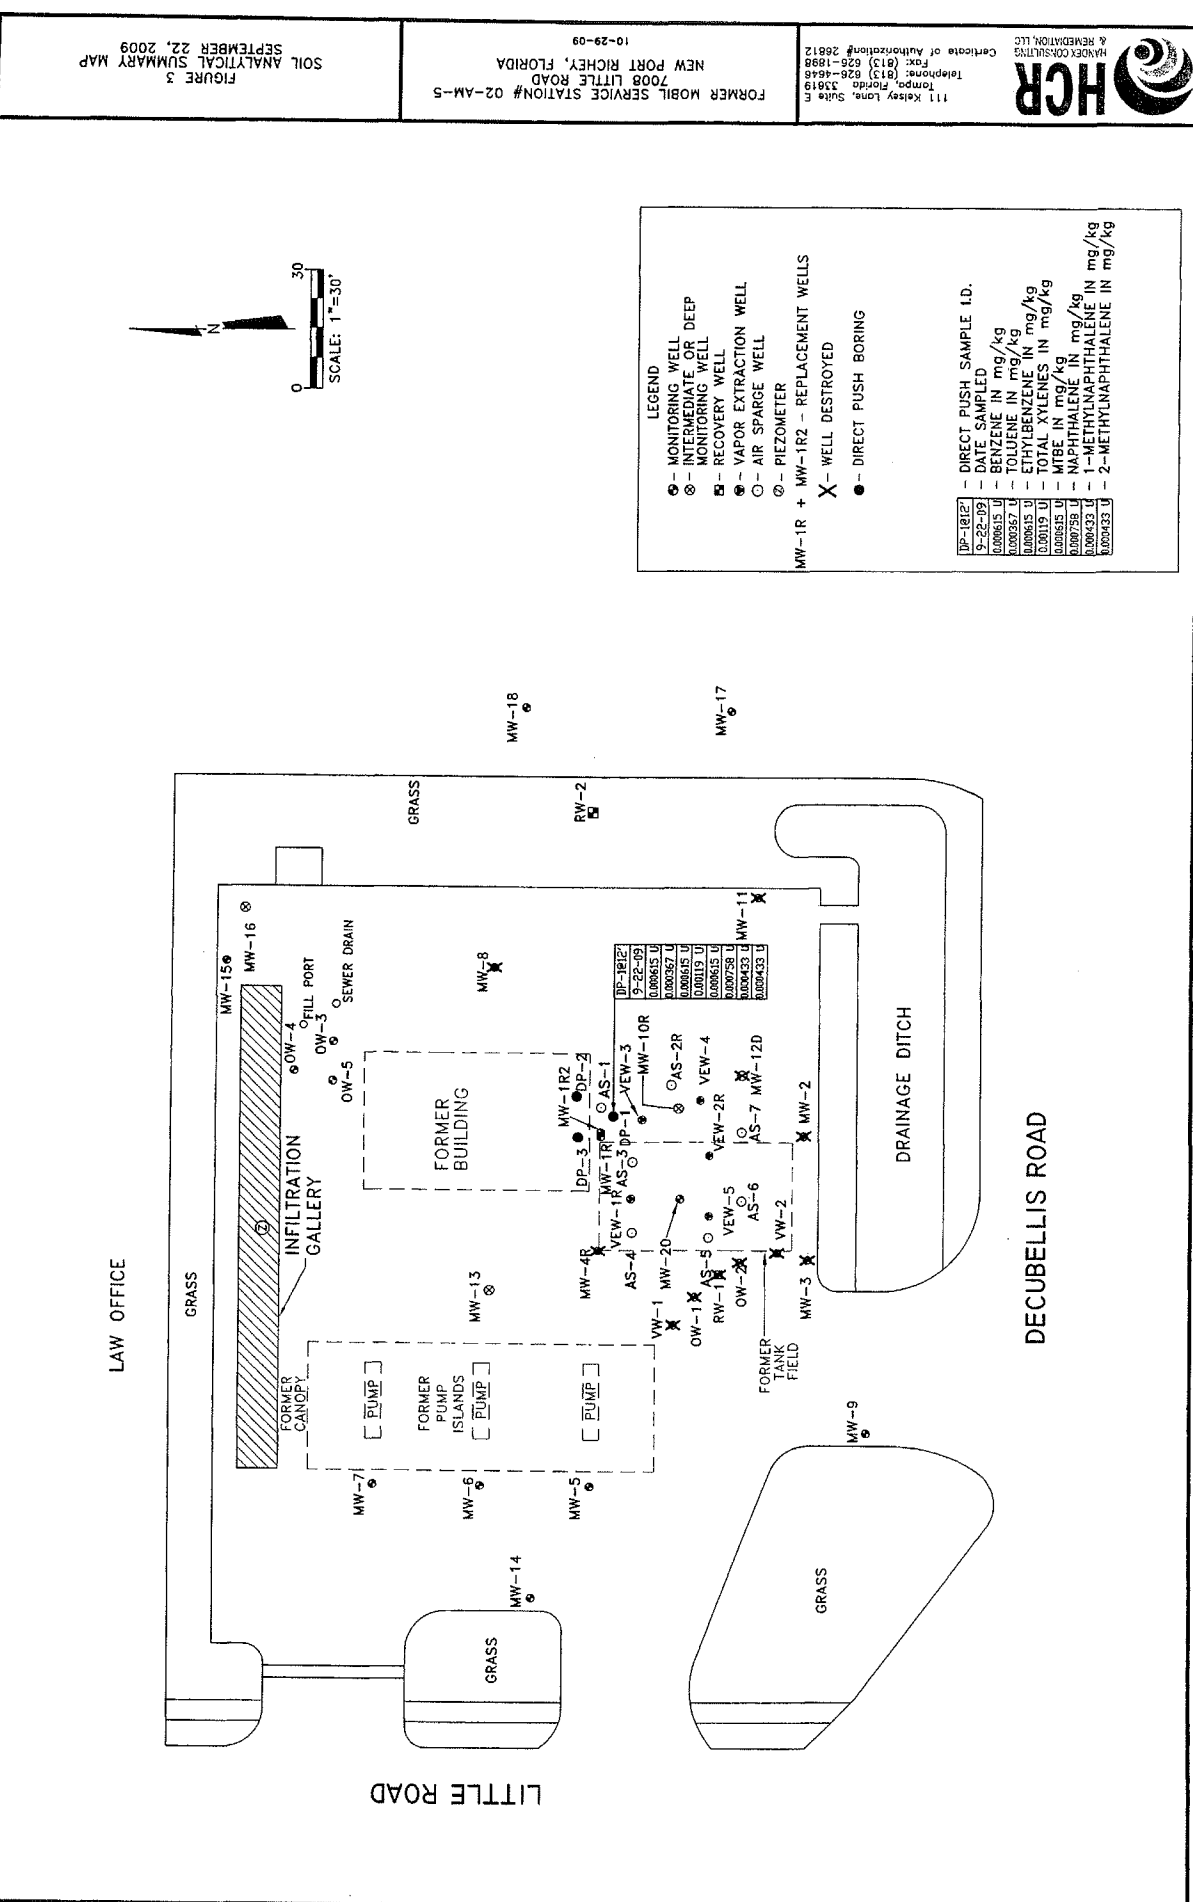
FIGURE 3
SOIL ANALYTICAL SUMMARY MAP
SEPTEMBER 22, 2009

- - DIRECT PUSH SAMPLE I.D.
- - DATE SAMPLED
- - NET OVA FD HEADSPACE RESULTS IN (ppm)
